Manhole Inspection Summary

Manhole # S31K__028MH

Location Address: **630 Emory St**

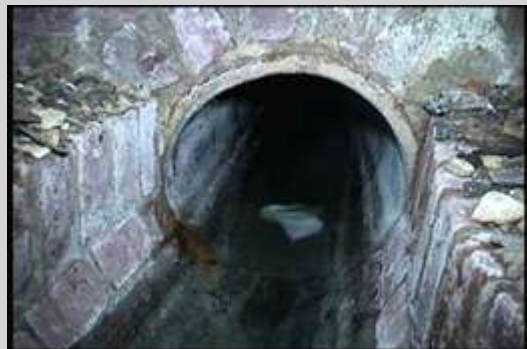
7 O'Clock Inflow

10 in. Circular Gravity Sewer
Pipe In @ 7 O'Clock

Pipe Height: **10.8** (in.) Rod and Bar (Angled)

Pipe Material: **Clay** ☐ Pipe Lined
